**BLACKSTONE RIVER BASIN  
MILLBURY, MASSACHUSETTS**

**DOROTHY POND DAM  
MA 00146**

# **PHASE I INSPECTION REPORT NATIONAL DAM INSPECTION PROGRAM**

**JULY 1978**

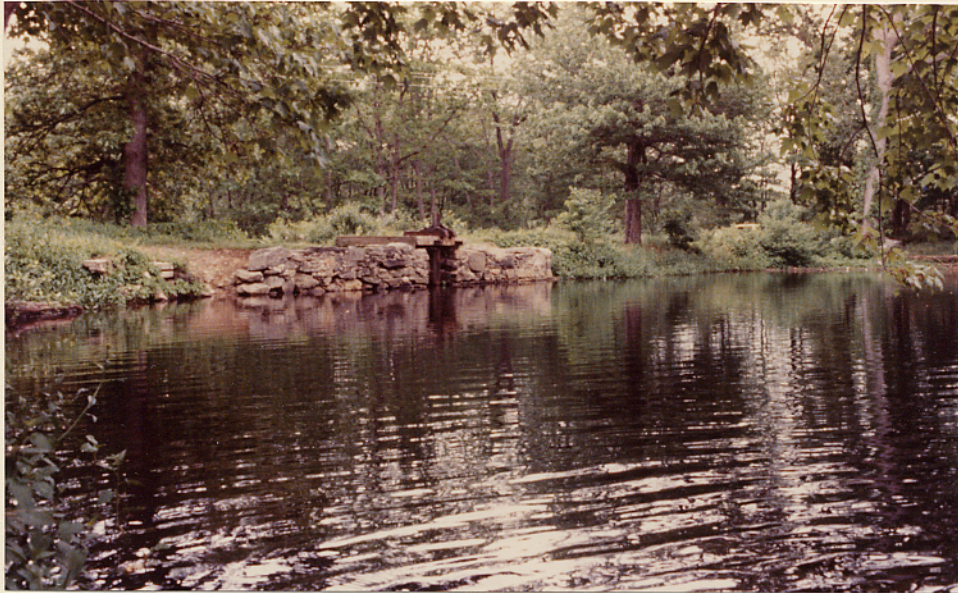
**VIEW OF UPSTREAM EMBANKMENT AND HEADWALL**

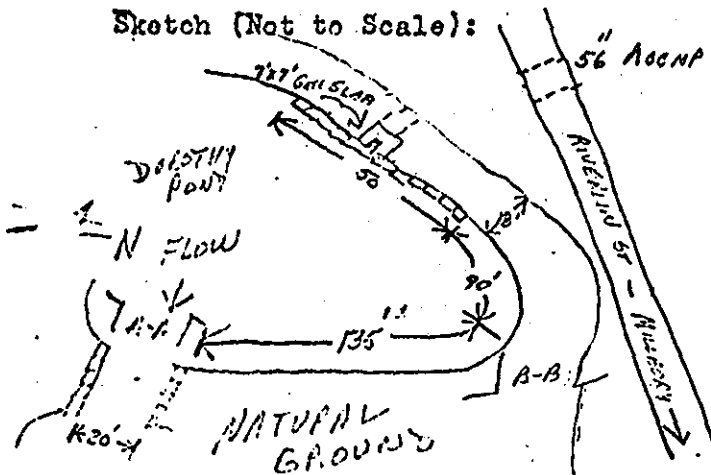
A-A SIDEVIEW SPILLWAY

General Description of Dam and Discharge Control: 24" DRAIN OFF PIPE  
24" OF TERRAZZO AT GATES, EARTHEN RUBBER, SPILLWAY 5' WIDE  
AT WESTERN END OF DAM MADE OF STONE MASONRY, 5-6 TREES  
18"-30" ON DAM. SIZE OF GATES NOT SEEN BECAUSE OF ICE.

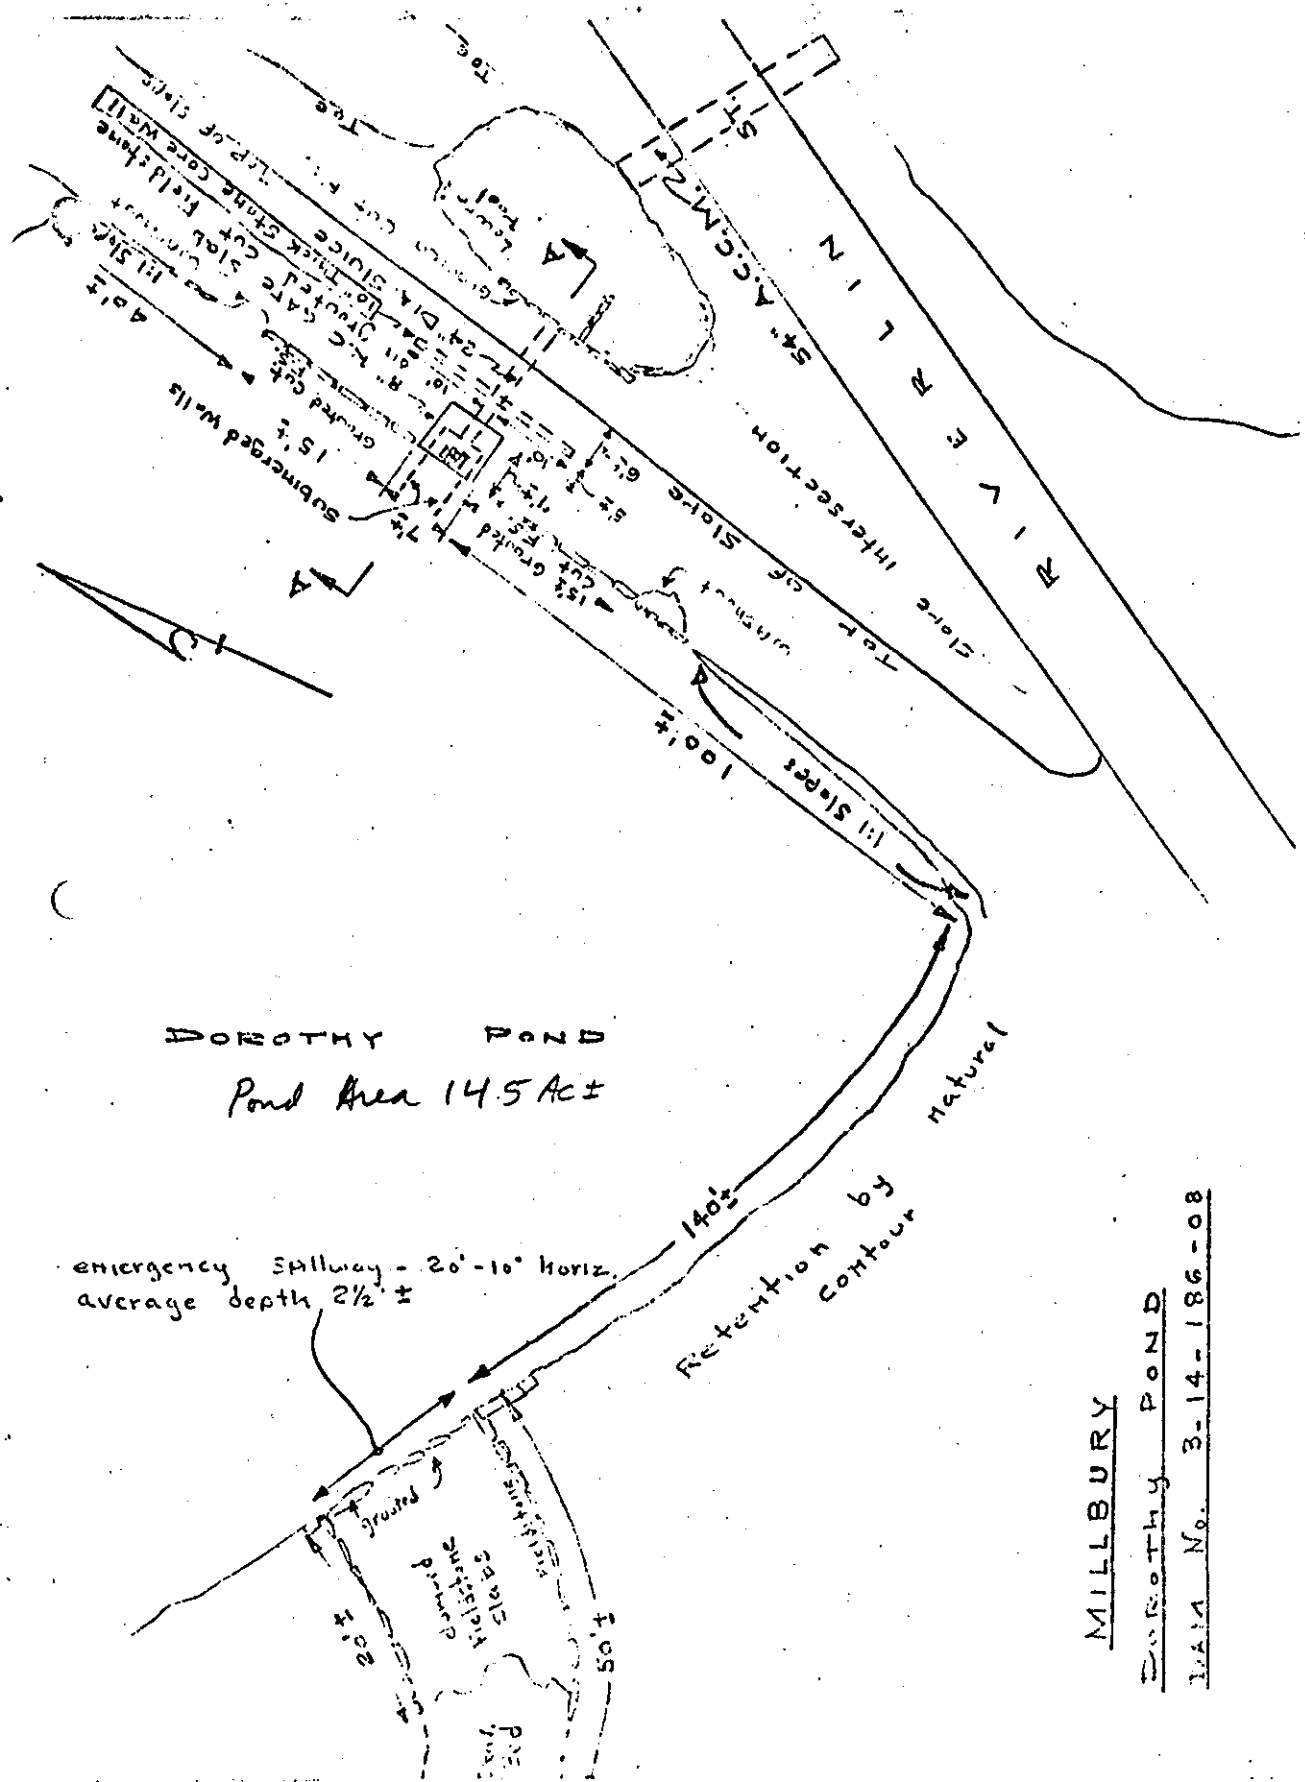
B-17

Since there are residences with Gravity wells adjacent to the Pond, the lower Pond Elev. may be unsatisfactory.

- ⑤ The deficiencies noted are significant; a Consultant should be retained to prepare a P.S. & E. for restoration.
